# **B** APPENDIX B: STRUCTURES AND BUILDINGS AT LONG VALLEY FARM and ASSESSMENT OF EXISTING STRUCTURES AT LONG VALLEY FARM

## **ASSESSMENT OF EXISTING STRUCTURES**

### **at Long Valley Farm**

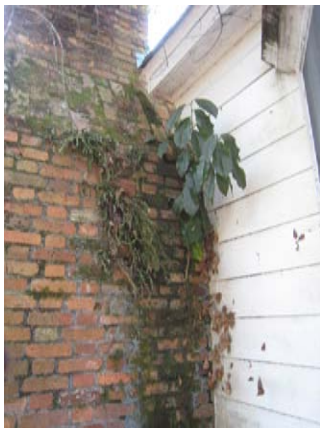
1. overgrowth and deterioration to chimneys
2. moss growth on roof
3. overgrowth and siding deterioration

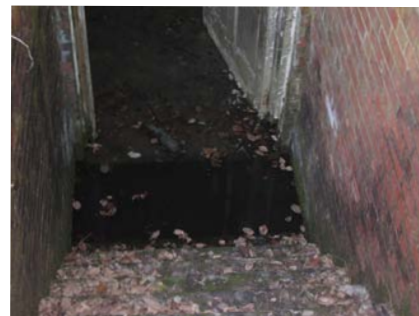
Notes: standing water in basement, potential water issue on north-east brick terrace at wall connection (trapped leaves and moisture between brick terrace and house)

4. stair and main hallway
5. basement door at stairs with moss, standing water and vine growth
6. large kitchen

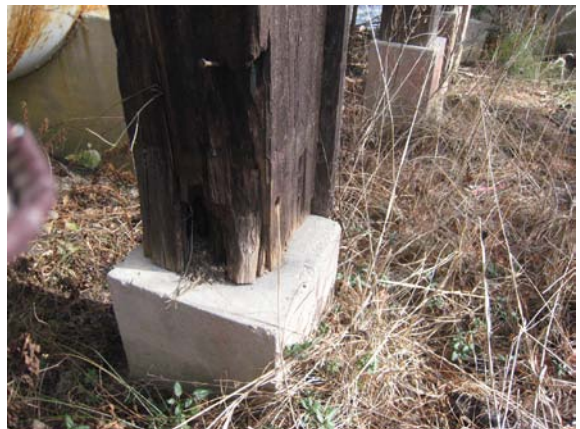
4

4. concrete pile foundation
5. lever arm for dam gate

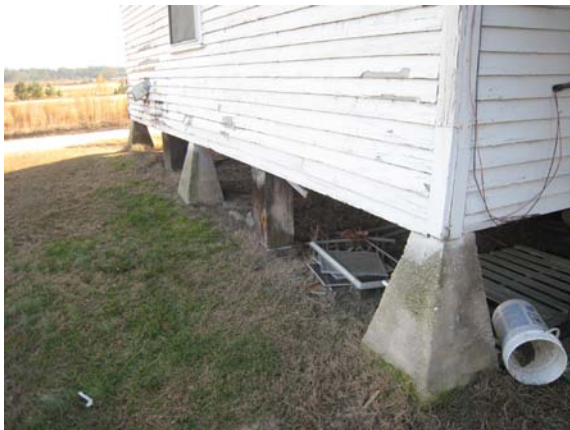
1

1. foundation
2. paint peeling from siding
3. entry porch damage, siding damage

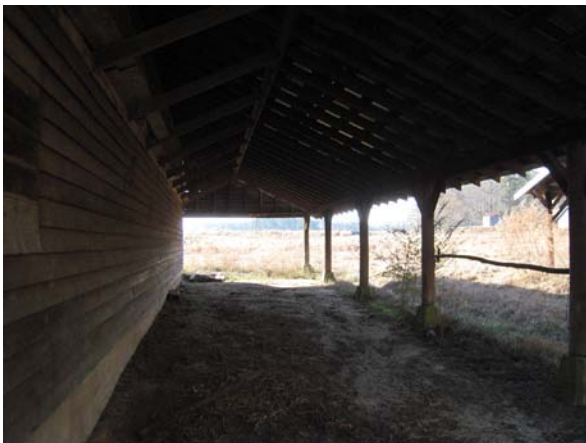
1

1. shed covering
2. metal roof damage
3. fence and shed
4. foundation cracks
5. inside, roof
6. underside of roof

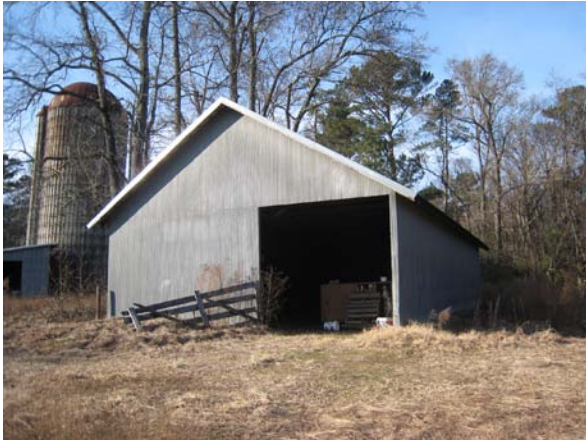
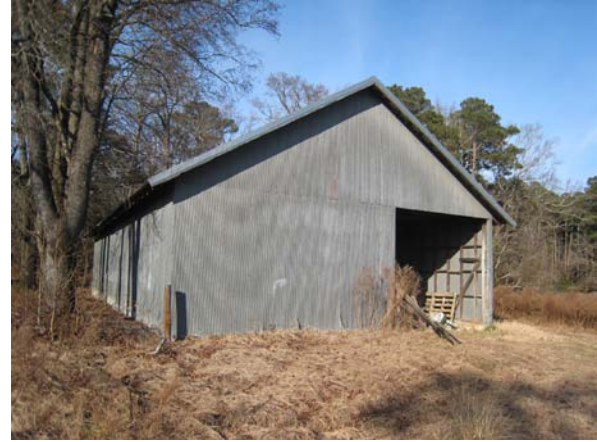
## 29. HAY BARN

**Foundation System:** poured concrete and dirt floor

Condition: fair

Condition: fair to good

Notes: appears structurally sound, old repairs apparent

Notes: doors were untested but likely require some repairs to work properly

**FCAP Recommendation:** reattach or replace damaged metal siding and roof panels; repair livestock doors and gates; trim back foliage adjacent to structure

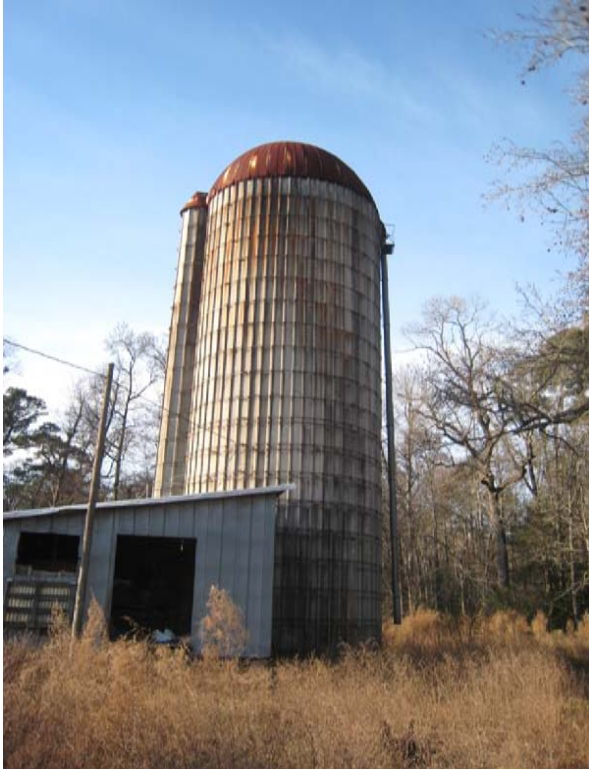
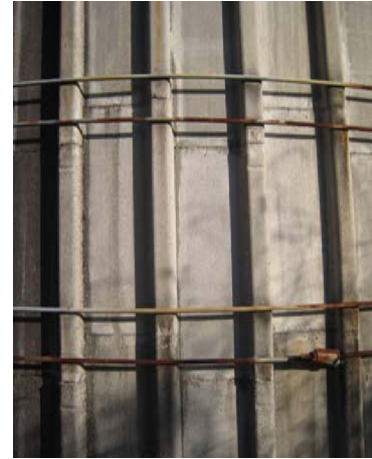
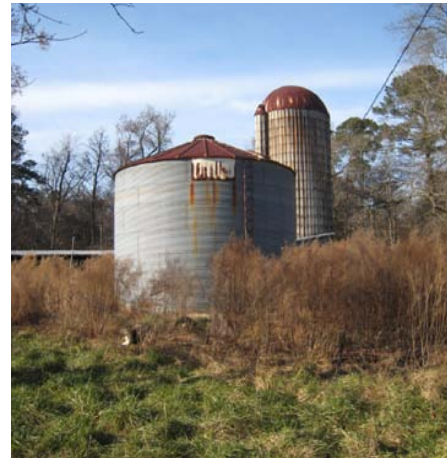
## 30. SILO

**Foundation System:** boardformed concrete

Condition: fair

Condition: fair to good

Condition: poor

Notes: rust covering entire roof

**Electrical:** none, wires cut

**Historical Value:** Although not a contributing structure to the original farmstead, it is an integral part of the farm and has a strong iconic value as a recognizable farming structure.

**FCAP Recommendation:** replace roof

1. Repair metal roof, restore concrete panels, and create secured viewing: \$12,000

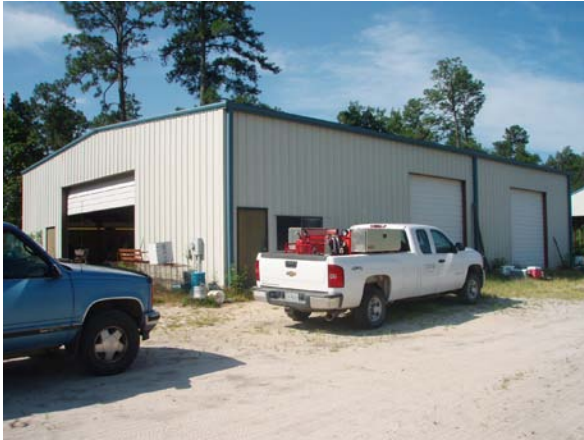
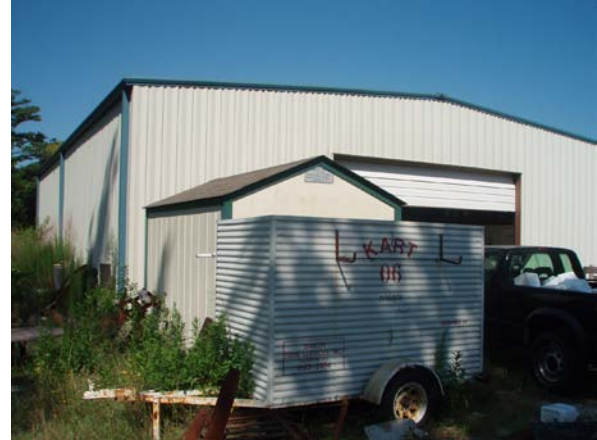
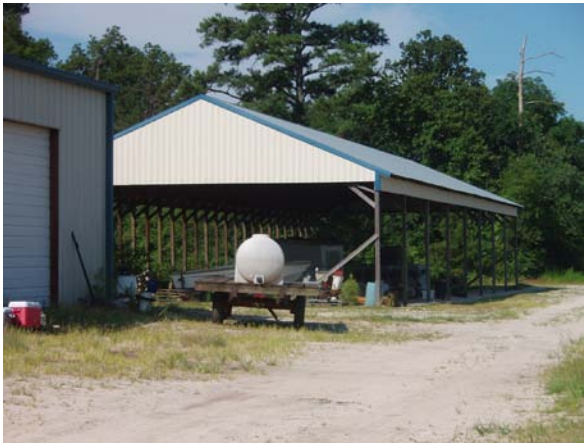
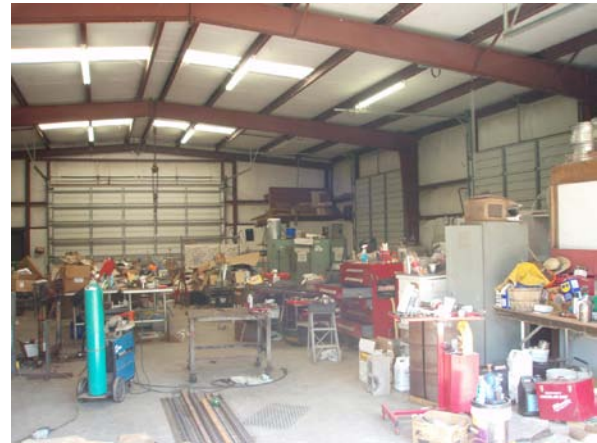
## 38. STORAGE SHED

**Foundation System:** slab on grade

Condition: good

**FCAP Recommendation:** upgrade electrical systems to meet code

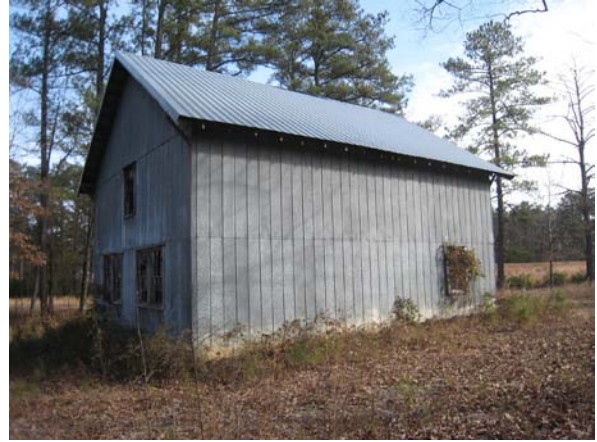
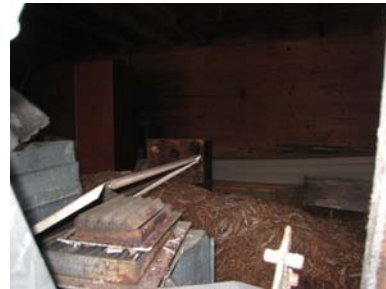
## 47. PACK HOUSE

**Foundation System:** concrete block piers, concrete apron with crawl space. Wood floor over joists.  
Condition: fair  
Notes: holes in apron on north side

**Structural System:** 2x8 wood frame  
Condition: fair  
Notes: 2 stories (bowed 2nd story floor)

**Cladding System:** vertical metal 5V siding  
Condition: fair  
Notes: none

**Roof System:** joists and rafters with metal 5V roofing  
Condition: fair  
Notes: none

**FCAP Recommendation:** replace roof, wood door, and windows; repair metal siding

1. Clean debris out of inside, cut back over grown trees in drip line, repair exterior only, and secure: \$30,000
2. Demolish: \$5,000

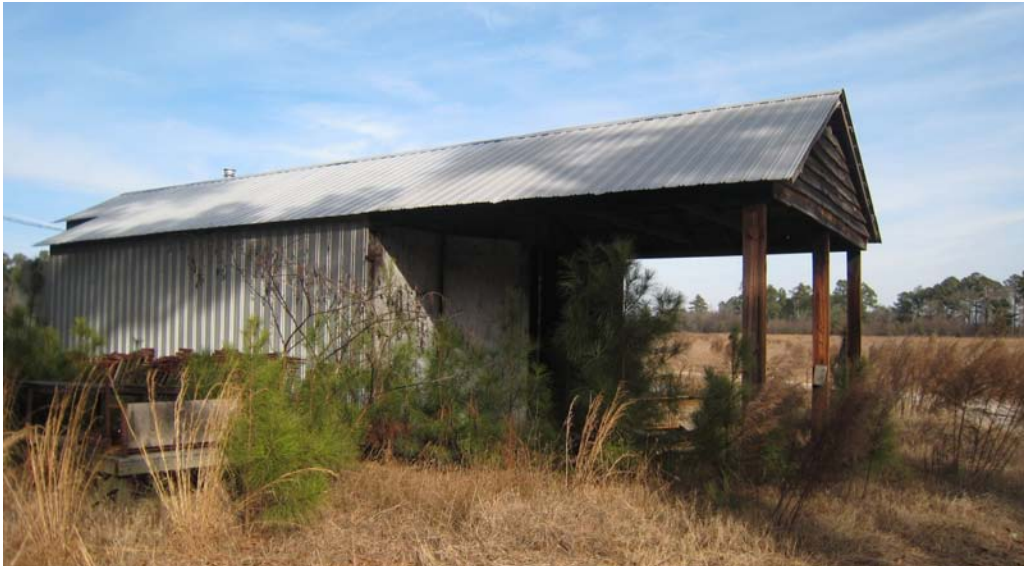
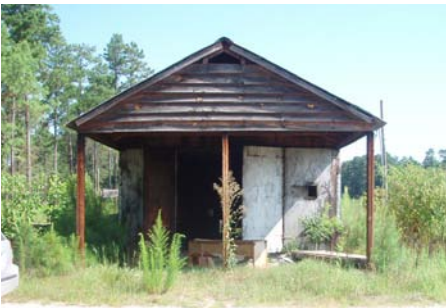
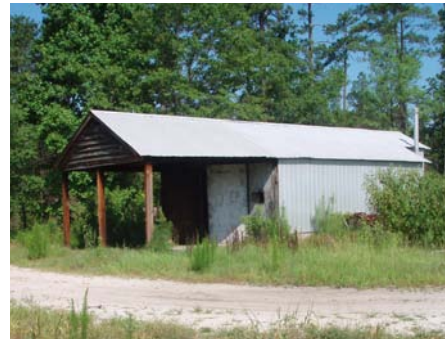
## 48. BULK TOBACCO BARN

**Foundation System:** concrete block, dirt floor  
Condition: fair  
Notes: cracking

**Structural System:** 2x4 wood frame inside, 2x8 doubled porch posts  
Condition: good

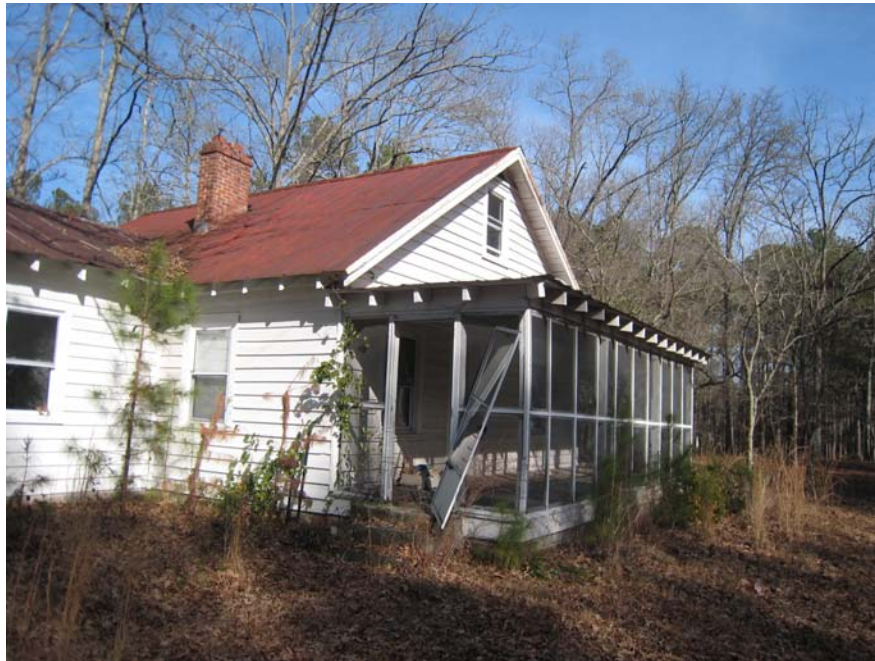
## GENERAL OBSERVATIONS

**Foundation System:** concrete block

Condition: fair

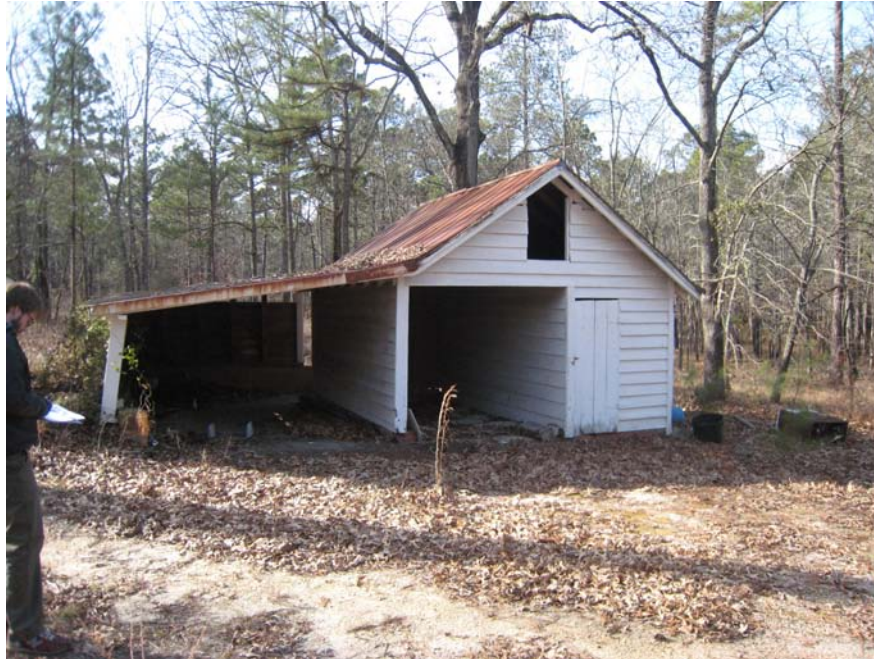
### GENERAL OBSERVATIONS

**Foundation System:** concrete block and masonry

Condition: poor

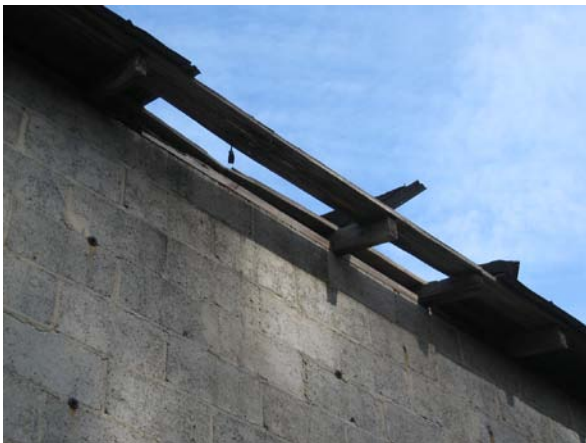
1

1. exterior roof, missing boards
2. interior space, low entrance, drying boards
3. roof structure, rot and holes

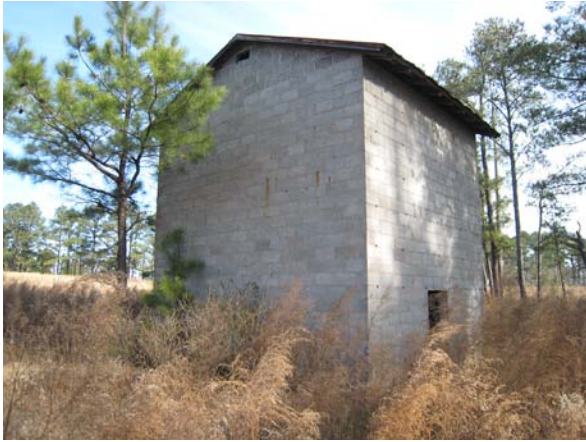
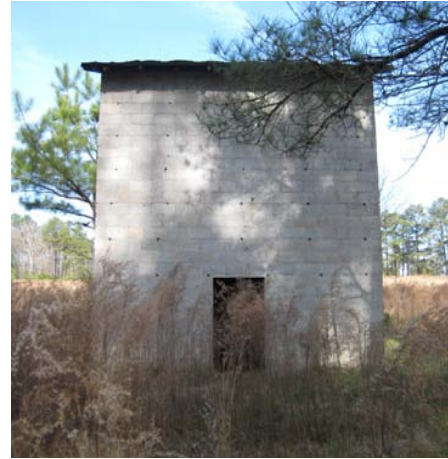
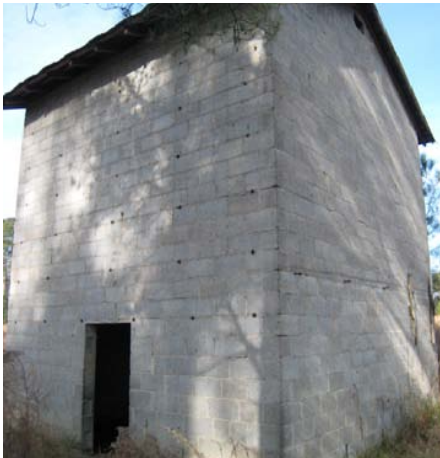
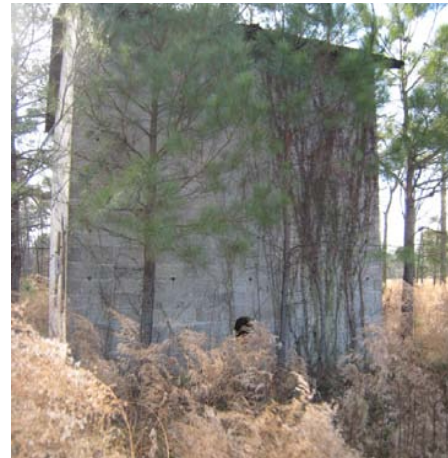
## 58. NORTH PASTURE TOBACCO BARN #2

**Foundation System:** dirt

Condition: fair
